## RESTORATION OF THE MOSAICS ON THE DOME OF THE SS. SACRAMENTO CHAPEL

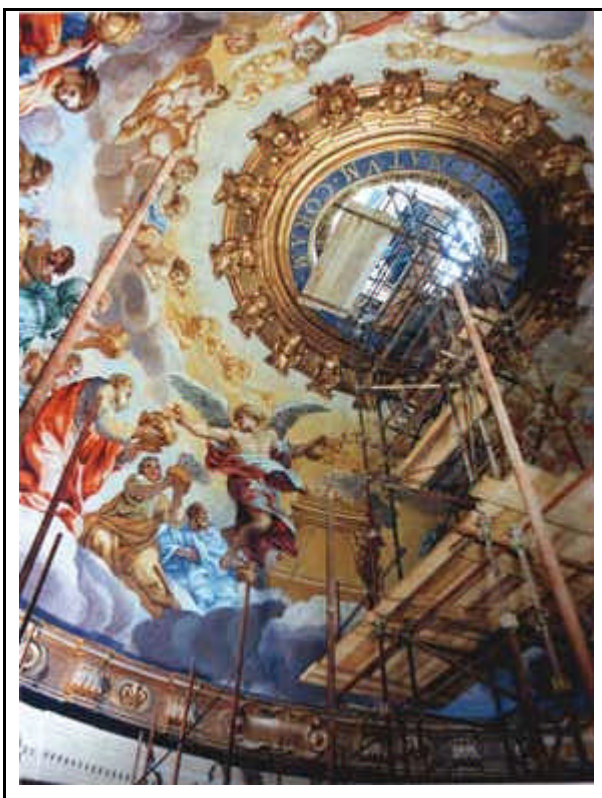
The dome of the chapel of SS. Sacramento is decorated by a mosaic depicting the mystery of the Eucharist, executed between 1656 and 1657 by artists from the Vatican

Mosaic Workshop on cartoons by Pietro of Cortona. Angels and blessed souls are portrayed offering vases of perfume, symbolizing the prayers of the faithful who are kneeling around the altar of the holocausts.

On the night of August 10, 1992, a considerably large piece of the mosaic decoration, including the lower part of the figure of the angel who is incensing the altar, came off the intrados of the dome.

documentation and a relief preceded the mosaic restoration. Subsequently the vault was cleaned of smoke and deposits of oily substances.

It was necessary to remove a considerable part of the decoration. Its design was copied onto vegetable paper; it was then applied to the surface to be removed with «velatino» (veiling), a tightly meshed gauze covered by a thick, water-soluble glue, that the master mosaicists framed into 700 small parts, labeled according to a reference grid that followed the design of the decoration. Once the "spillatura" (tapping), or the removal of the stucco from the cracks of the tesserae, had been carried out, the restoration of the missing parts began, using ancient enamels in a range of more than 20,000 different colors kept at the Vatican Mosaic Workshop.
